## **HOT KILN ( dryer ) ALIGNMENT ANALYSIS**

### **Sample report of hot kiln alignment in**

Plant ----- Cement Co

Kiln No : 1 ( 4 pier )

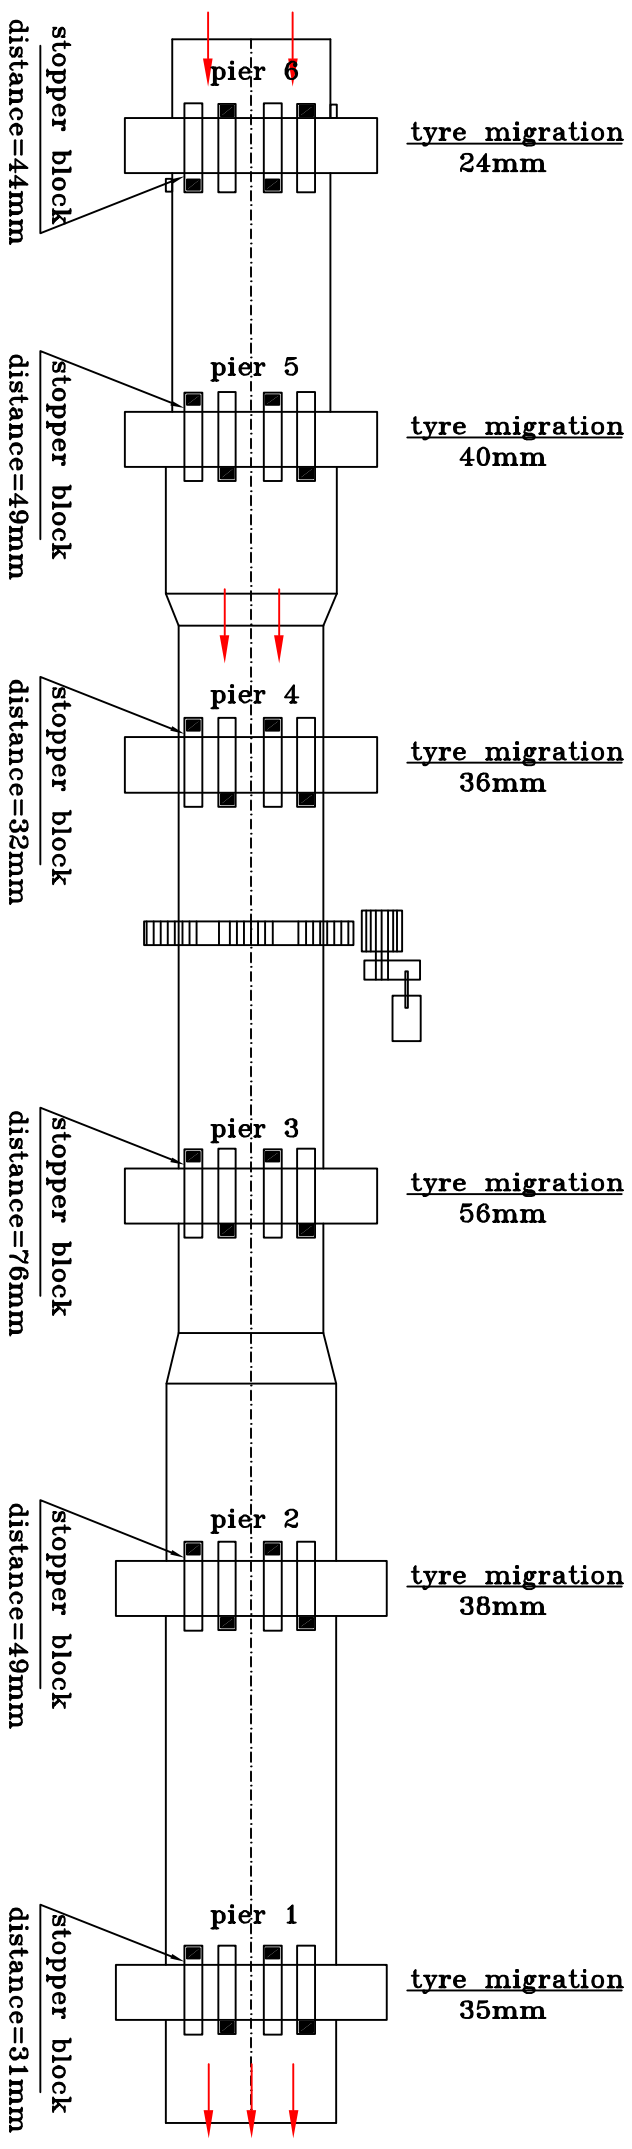
shim = 0

shim = 3.5mm

shim = 3mm

shim = 5.5mm

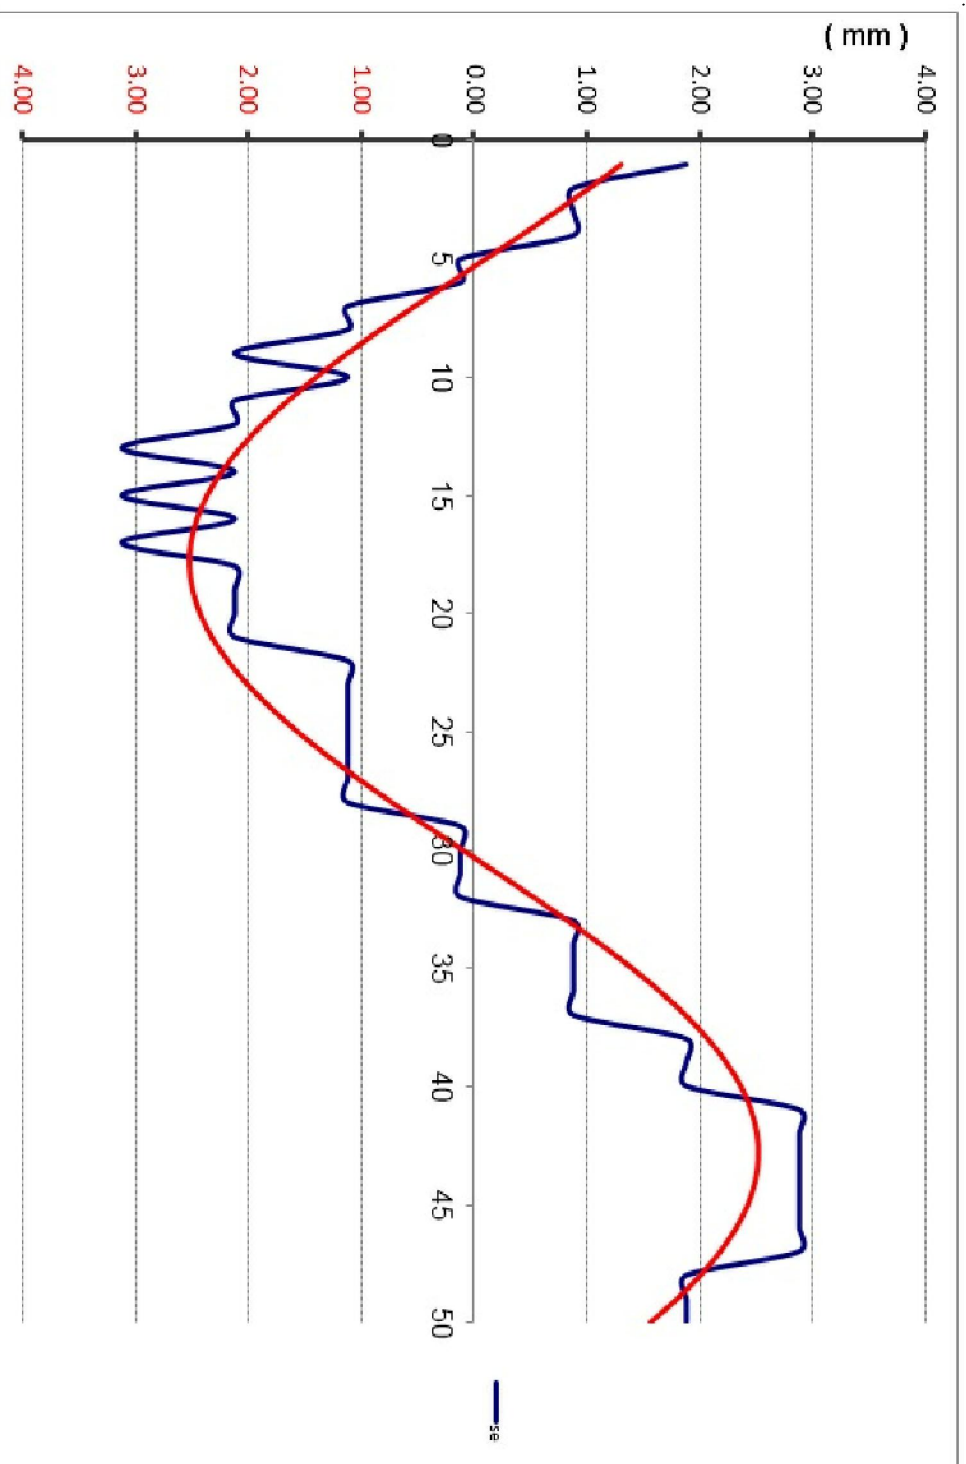
Inlet tyre wobbling = 2.5mm

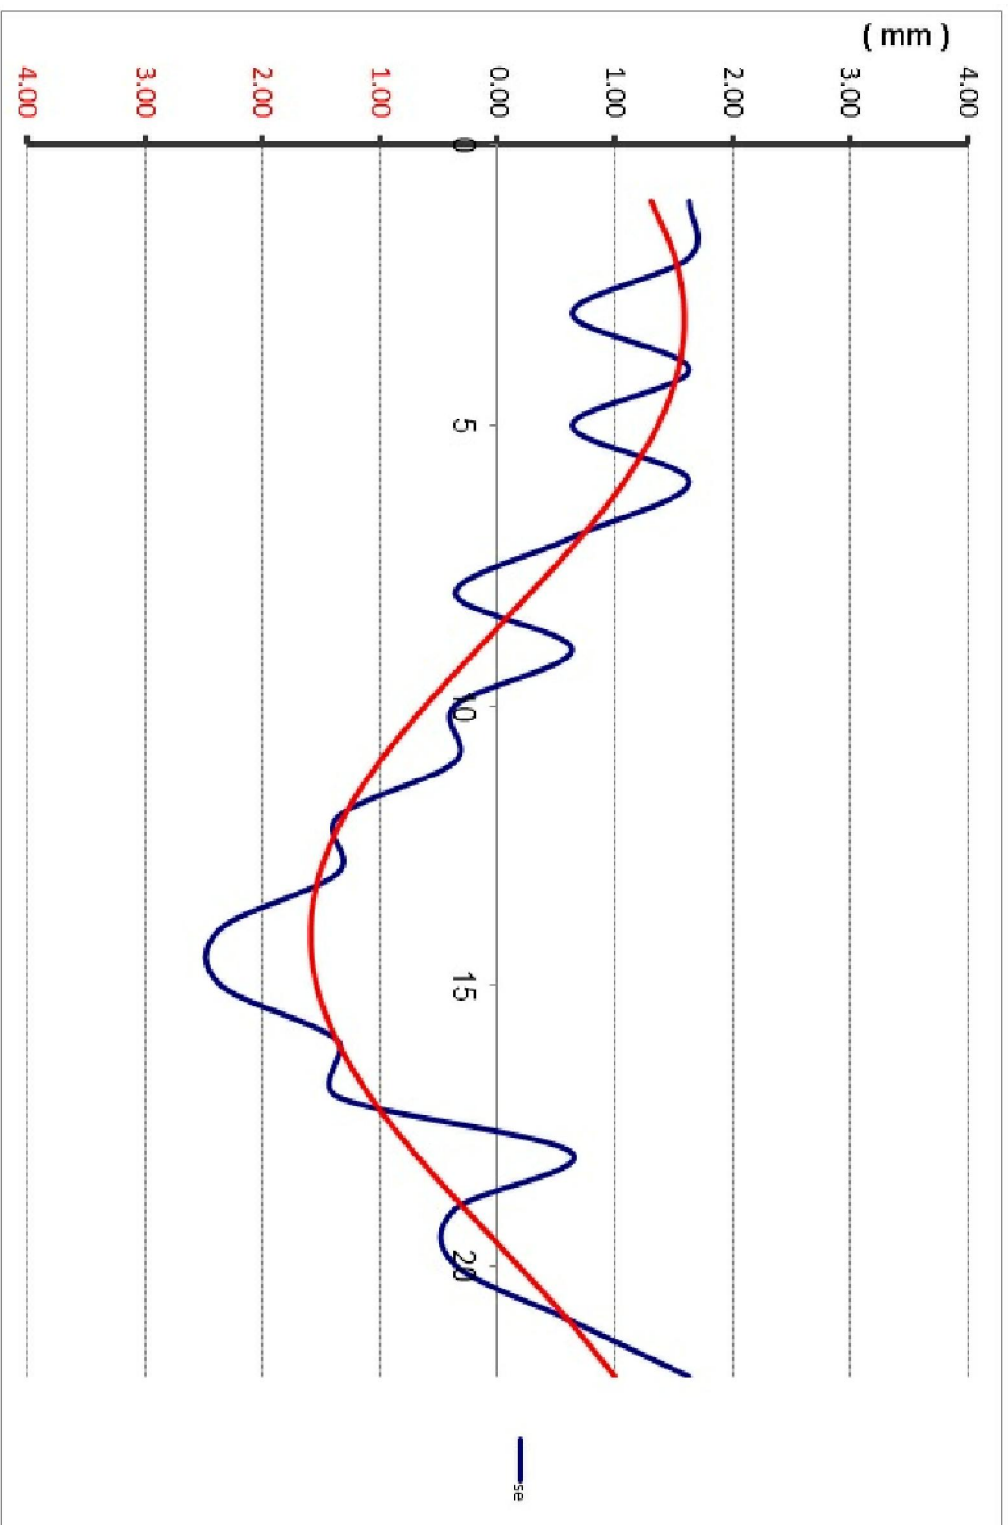
outlet tyre wobbling = 1.5mm

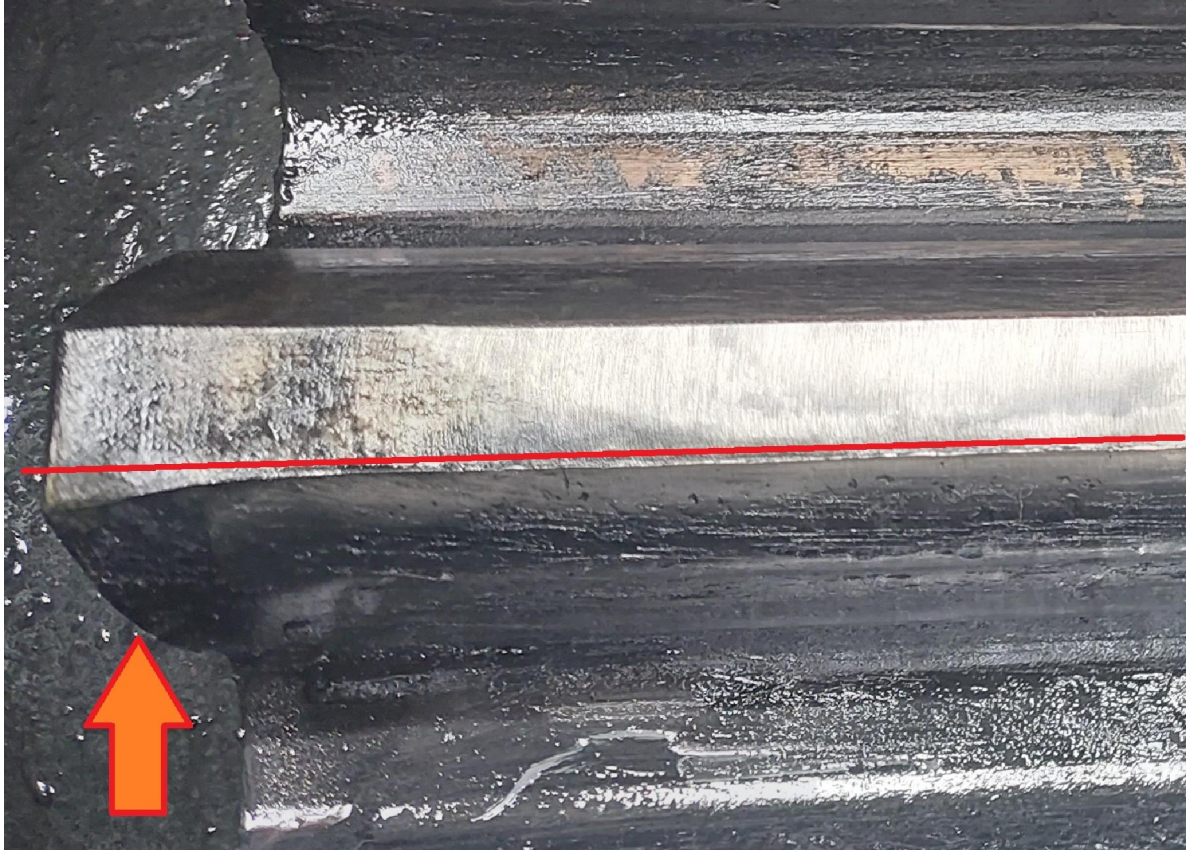
**There is a big problem in pinion teeth**

Pinion teeth needs grinding.

You can also use angle grinder to repair the teeth edges .

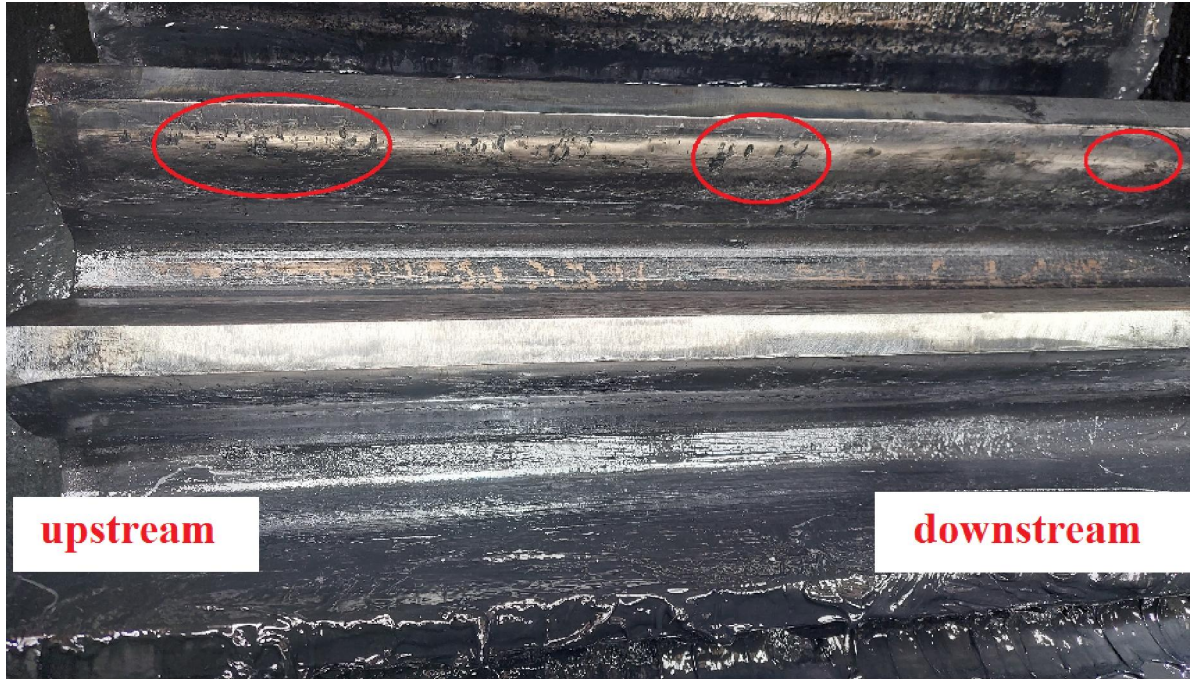
More contact upstream of the pinion and also more pitting.

Low contact downstream of the pinion and also low pitting.

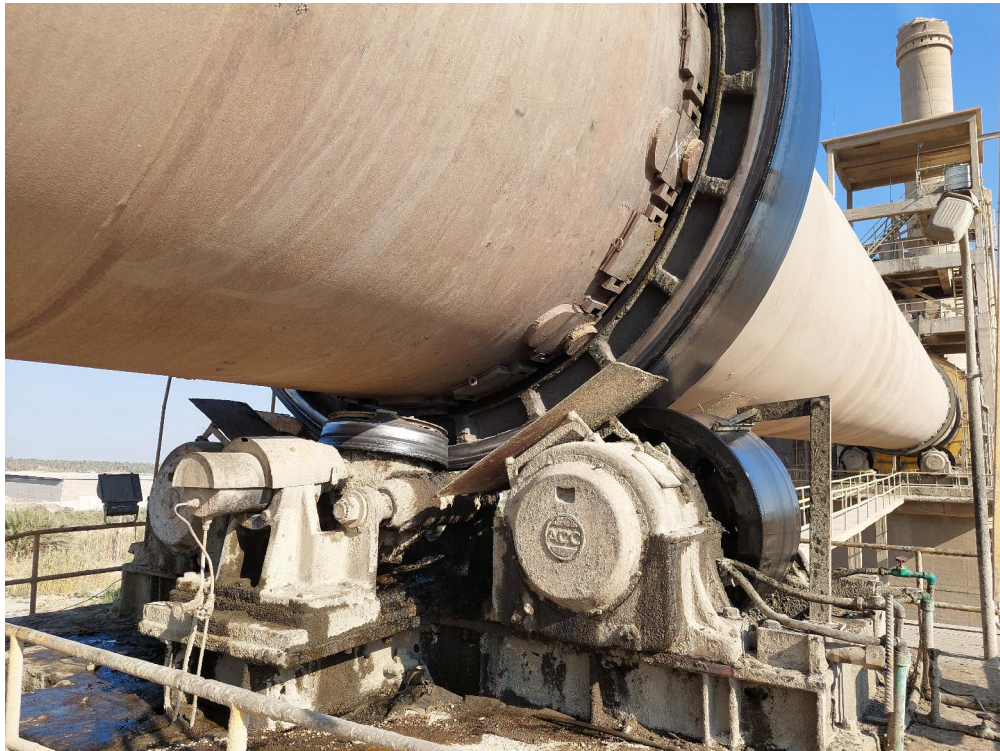
- Rollers temperatures in pier 1 and 3 and 4 are more than 70 degree .
- Kiln goes up and it doesn't have upper thrust roller .
- Kiln shell between pier 1 and 3 is in bad condition , highly run out and deformed . ( in some parts shell needs to be changed )
- Kiln shell between pier 3 and 5 is in good condition.
- Kiln shell between pier 5 and 6 is in bad condition , highly run out and deformed. ( in some parts shell needs to be changed )
- Rollers shafts on pier 3 and 4 have very bad scratches and must be repaired or changed .

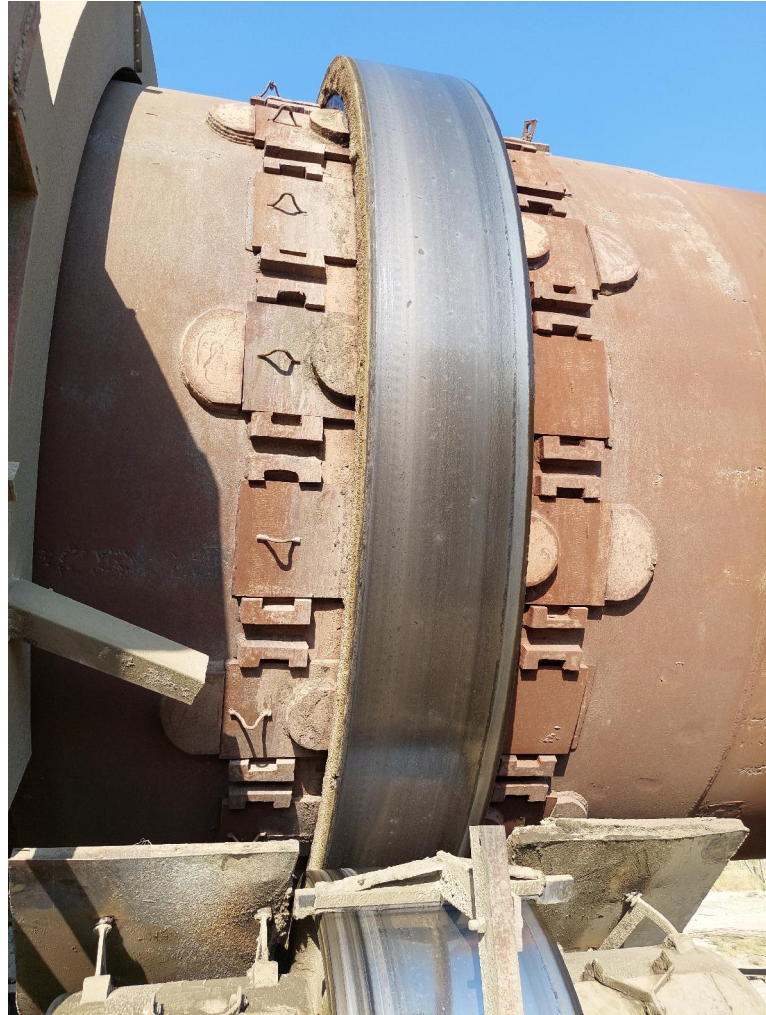
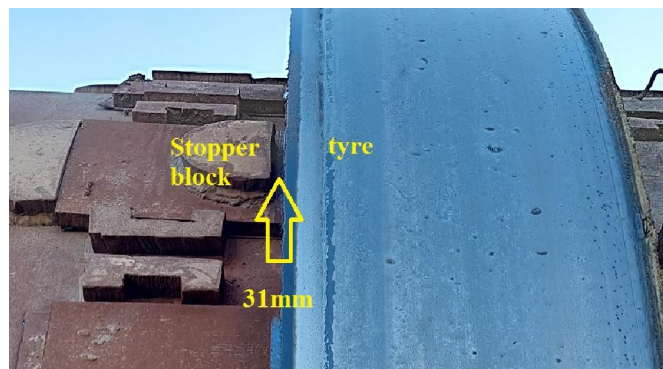
**Pier No 1 :**

- Tyre surface is in good condition .it doesn't need grinding or resurfacing
- Migration of this tyre is 35mm per revolution . ( standard creep is 10mm to 25mm in one revolution )
- It need 3mm shim between tyre and shell to improve migration .
- Distance between tyre and the upper stopper block is 31 mm ( standard is 2 mm to 5 mm )

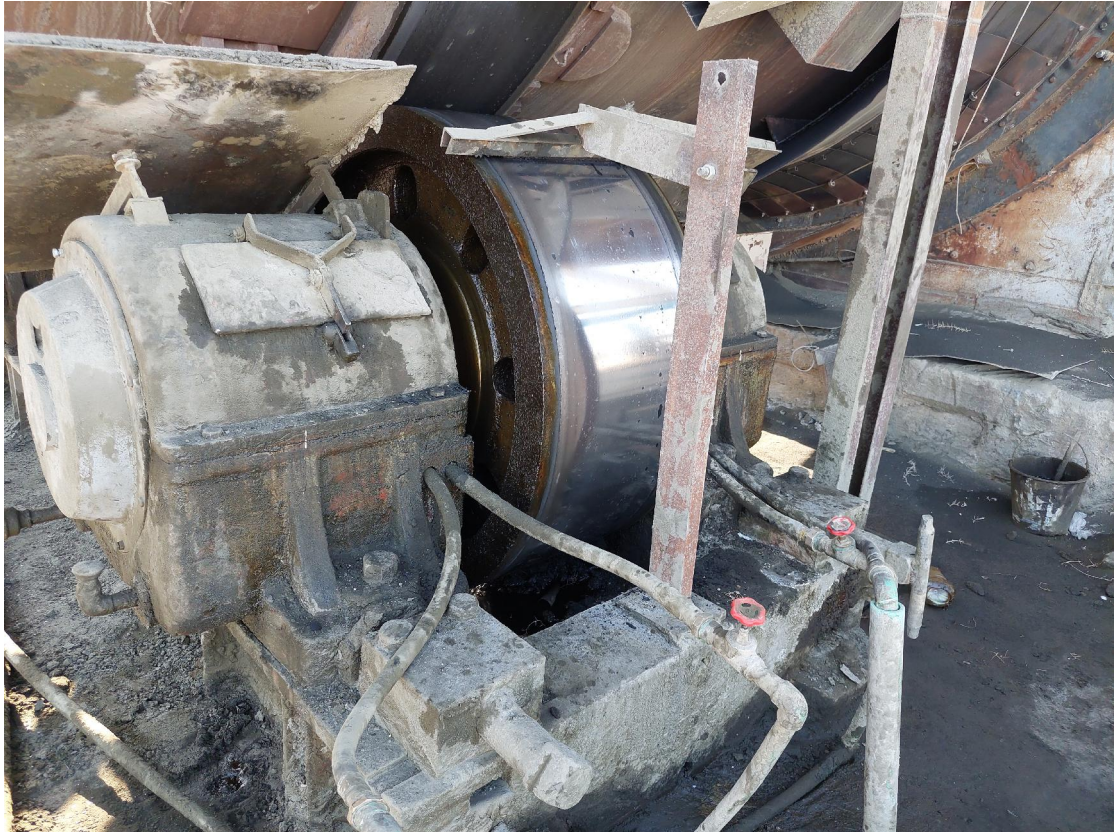
**Pier No 1 : Left roller ( non motor side )**

- roller surface is in good condition .it doesn't need grinding or resurfacing
- bearing temperature is 60 to 80 degree ( maximum acceptable temperature is 70 degree )
- roller shaft is in good condition .
- roller thrust collar is scratched .
- roller slope is 4.0% and it is good.
- V gap between roller and tyre is 25 % ( contact 75 % )

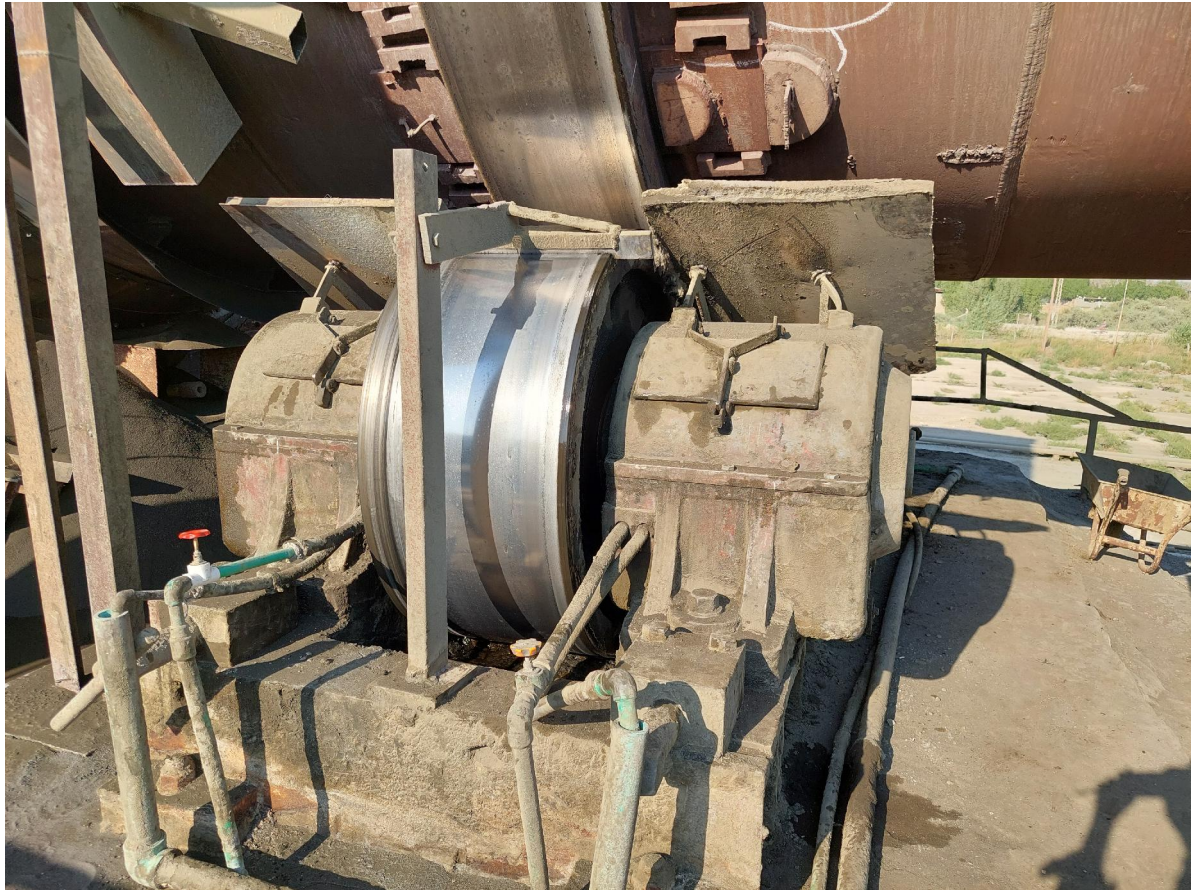
**Pier No 1 : right roller (motor side )**

- roller surface is in good condition .it doesn't need grinding or resurfacing
- bearing temperature is 75 to 100 degree ( maximum acceptable temperature is 70 degree )dangers
- roller shaft is in good condition .
- roller thrust collar is scratched .
- roller slope is 3.8% it need 3mm shim for upper bearing housing
- V gap between roller and tyre is 50 % ( contact 50 % )

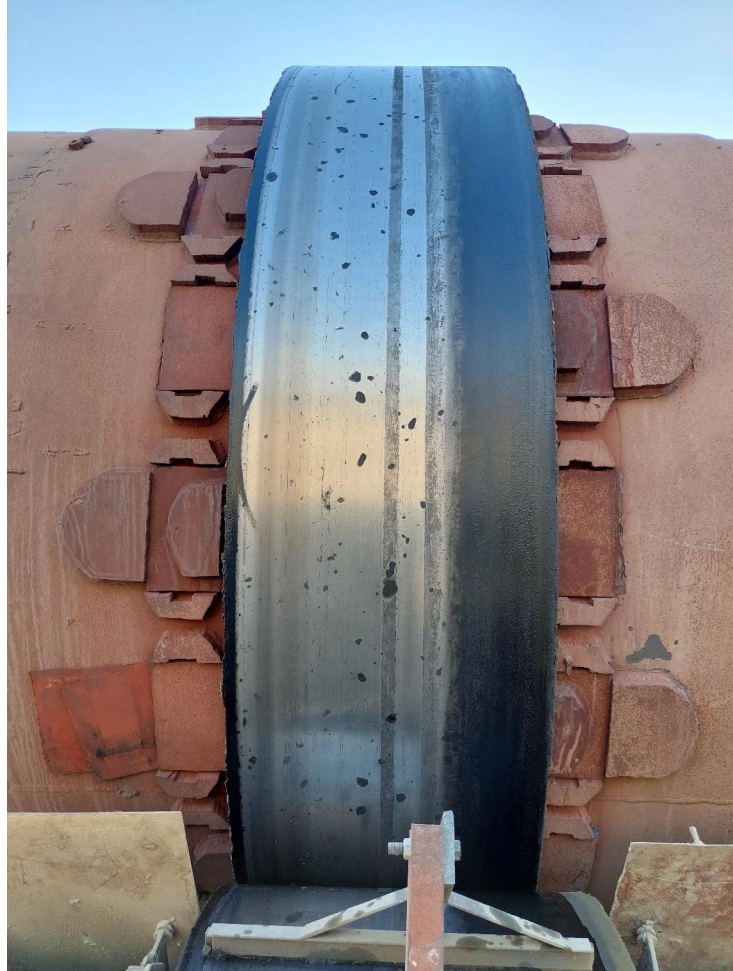
**Pier No 2 :**

- Tyre surface is in good condition .it doesn't need grinding or resurfacing
- Migration of this tyre is 38mm per revolution . ( standard creep is 10mm to 25mm in one revolution )
- It need 3mm shim between tyre and shell to improve migration .
- Distance between tyre and the upper stopper block is 49 mm ( standard is 2 mm to 5 mm )

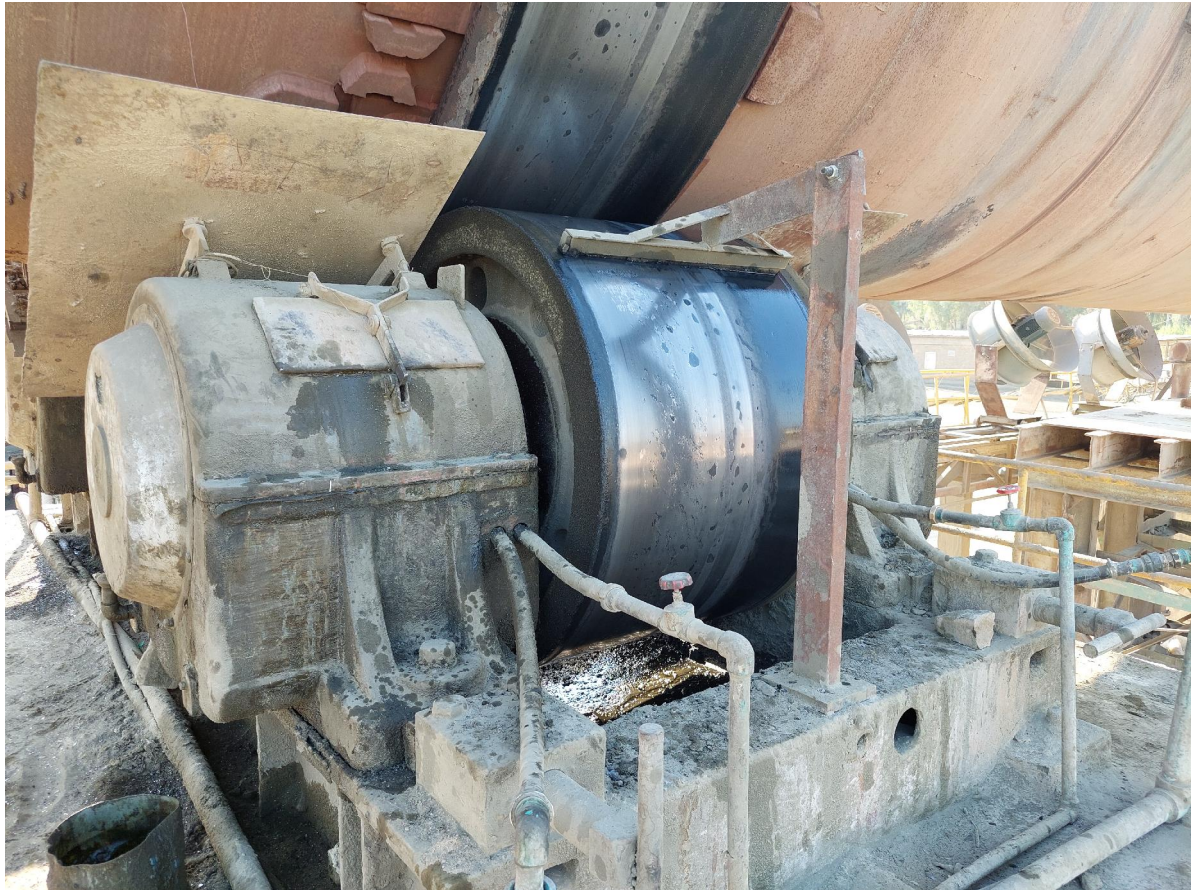
**Pier No 2 : Left roller ( non motor side )**

- roller surface is in good condition .it doesn't need grinding or resurfacing.
- bearing temperature is 60 to 80 degree ( maximum acceptable temperature is 70 degree ) temperature is ok .
- roller shaft is in good condition .
- roller thrust collar is scratched.
- roller slope is 4.0% ( it's ok )
- V gap between roller and tyre is 50 % ( contact 50 % )

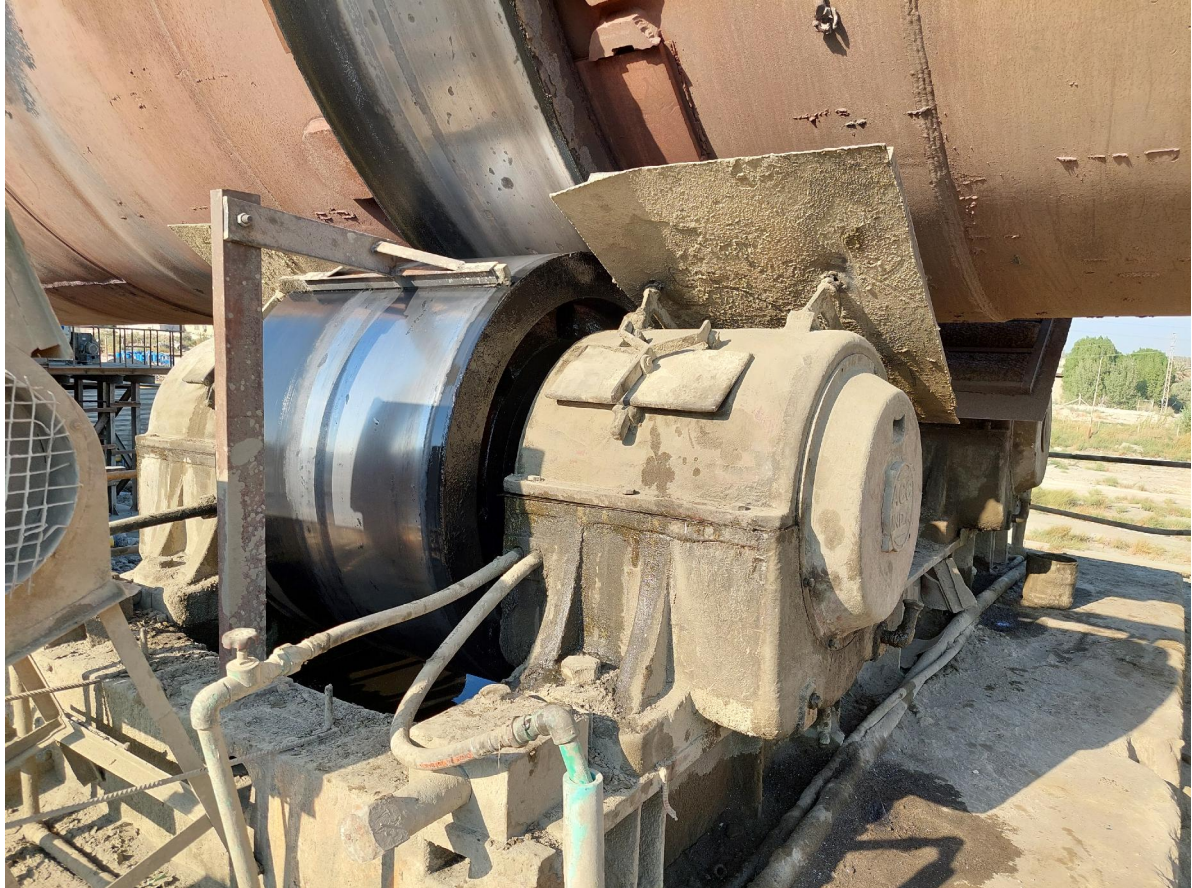
**Pier No 2 : right roller (motor side )**

- roller surface is in good condition .it doesn't need grinding or resurfacing
- bearing temperature is 60 to 75 degree ( maximum acceptable temperature is 70 degree )
- roller shaft is in good condition .
- roller thrust collar is in good condition .
- roller slope is 4.0% and it is ok .
- V gap between roller and tyre is 65 % ( contact 35 % )

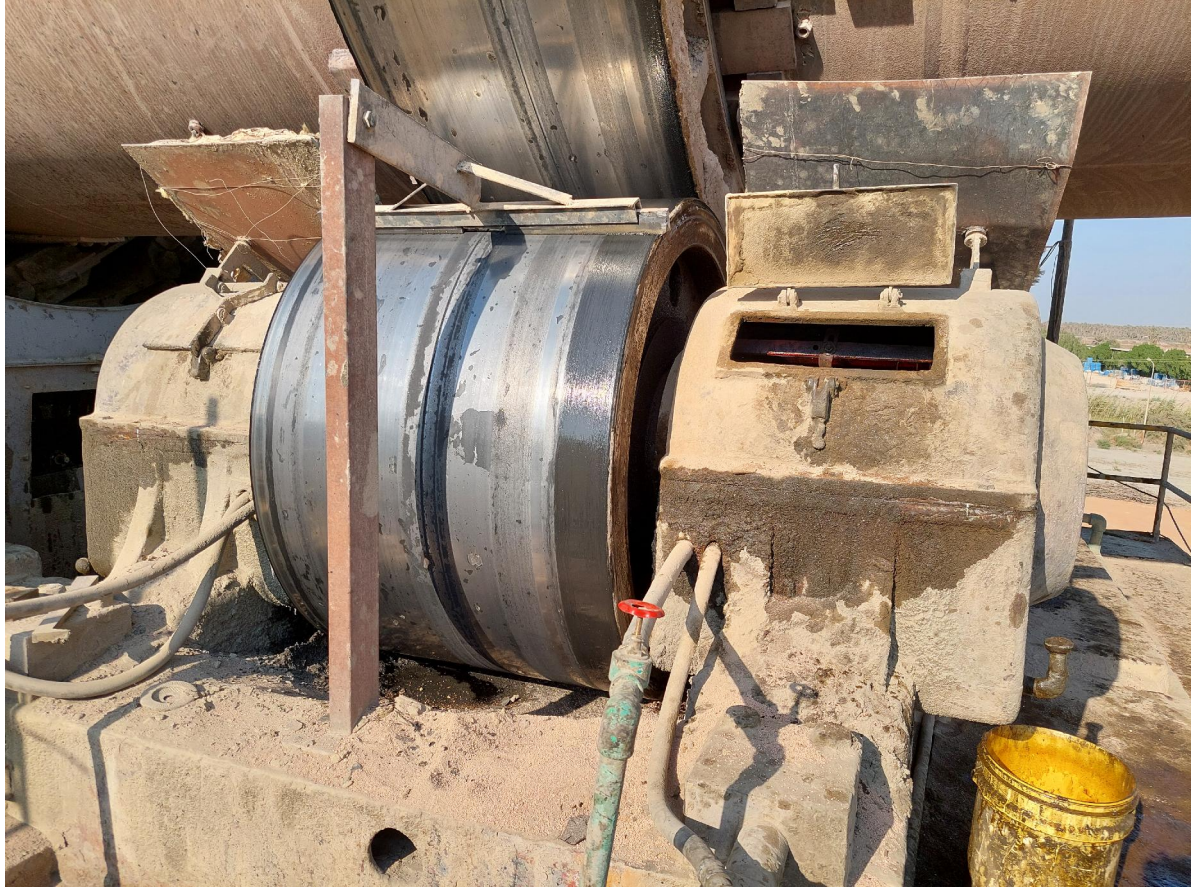
**Pier No 4 : right roller (motor side )**

- roller surface is in good condition .it doesn't need grinding or resurfacing
- bearing temperature is 70 to 120 degree ( maximum acceptable temperature is 70 degree ) dangers
- roller shaft is fully scratched , it needs to be changed or repaired .
- roller thrust collar has scratched .
- roller slope is 4.0% and it is ok .

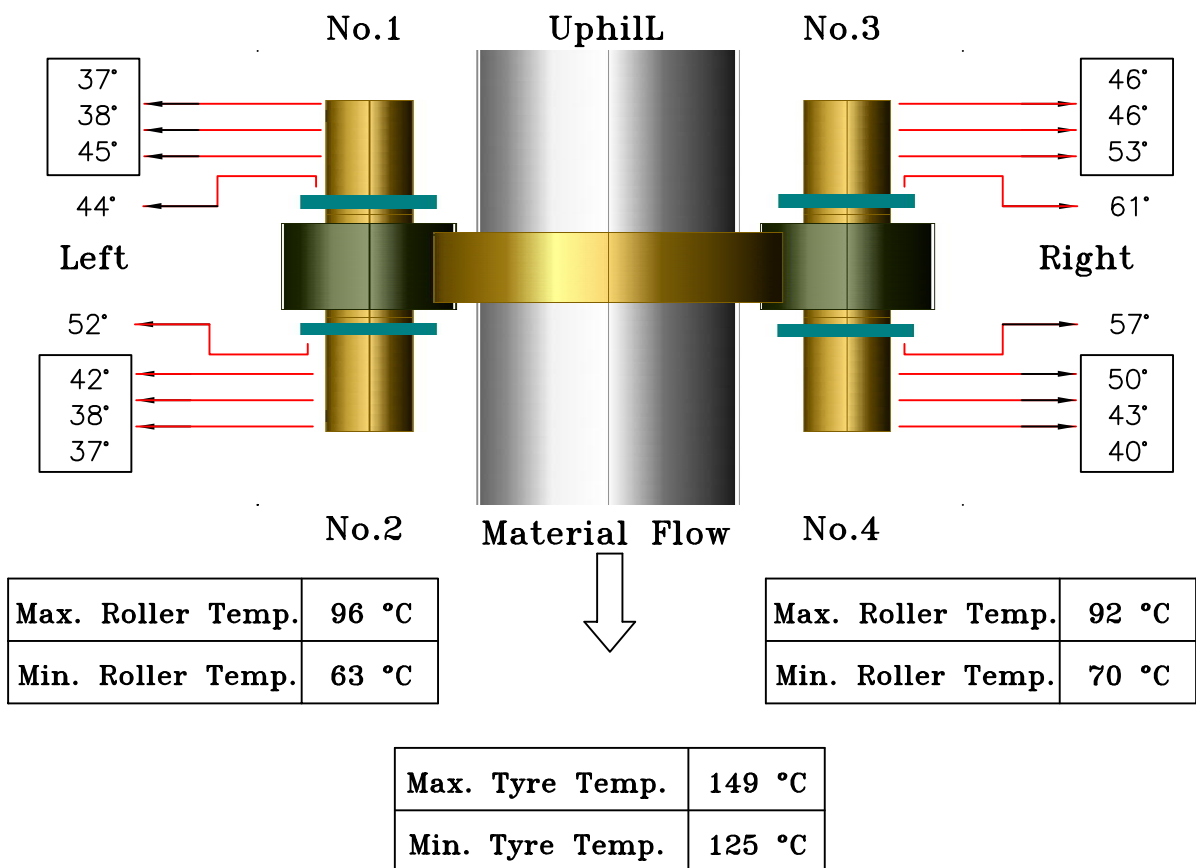
| Bearing No. | Journal | roller shaft surface | Lubricant | Oil tray distributor | Felt seal | Oil level | Water cooling |
|---|---|---|---|---|---|---|---|
| 1 | OK | OK | dirty | None | OK | OK | OK |
| 2 | OK | OK | dirty | not adjust | OK | OK | OK |

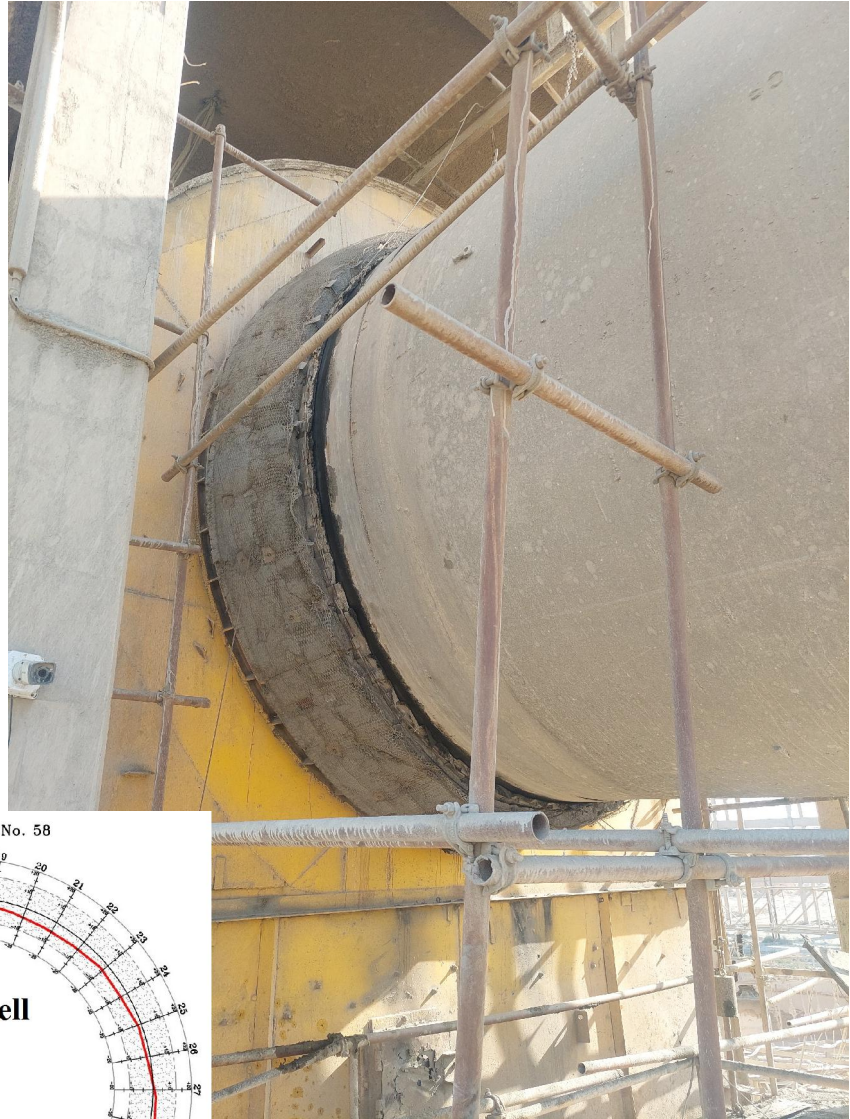
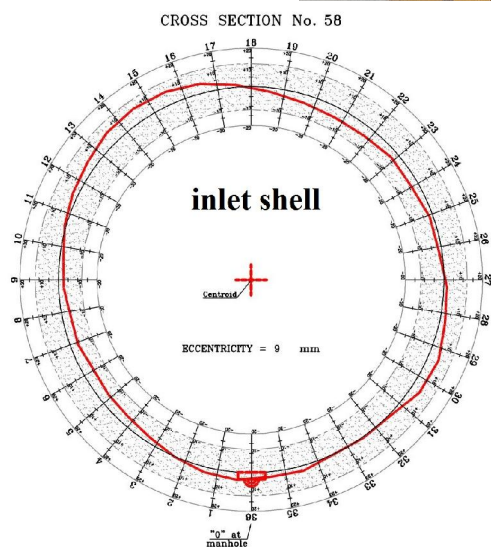
**Inlet seal :**

- Inlet seal is ok . it is in good condition .

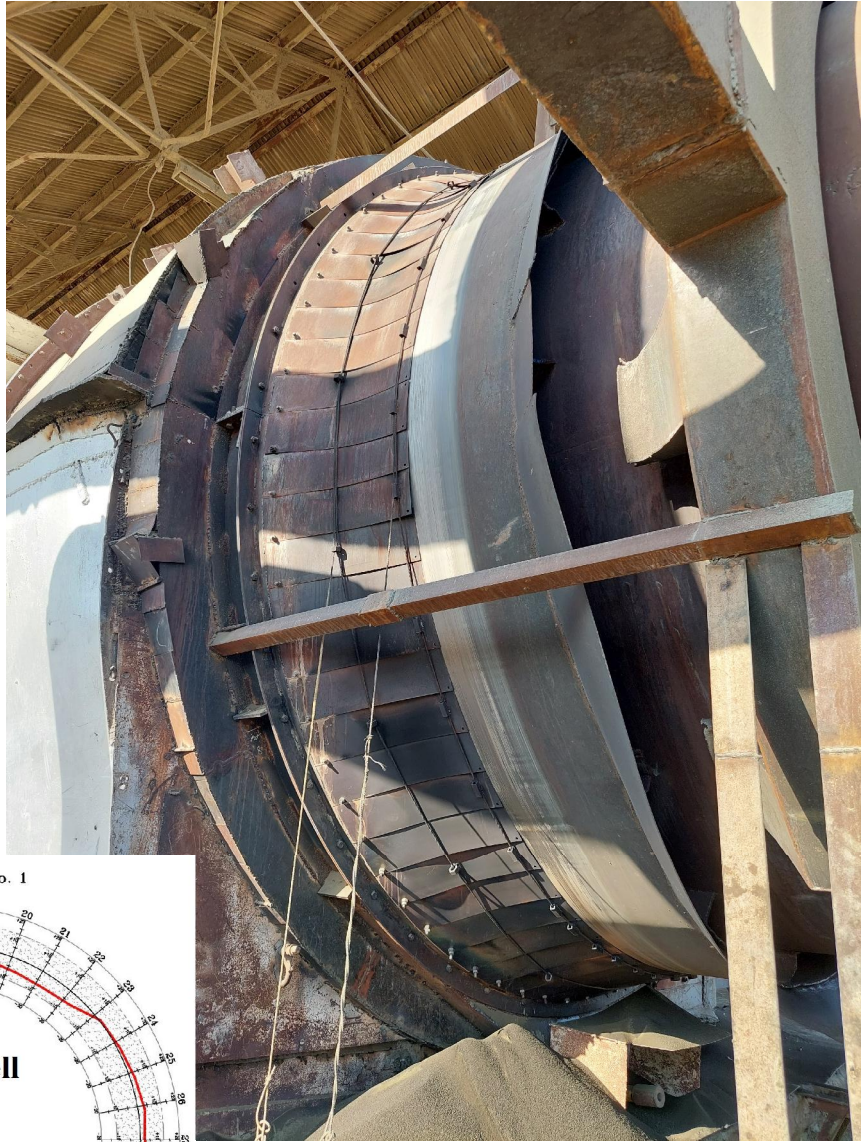
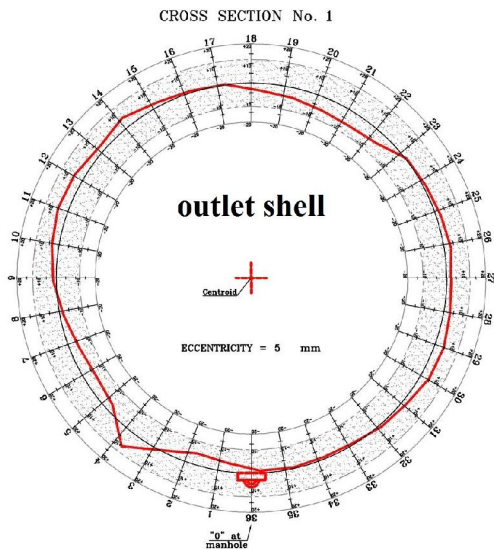
**Outlet seal :**

- outlet seal is ok . it is in good condition .
- because of high run run out few material pure out of the seal

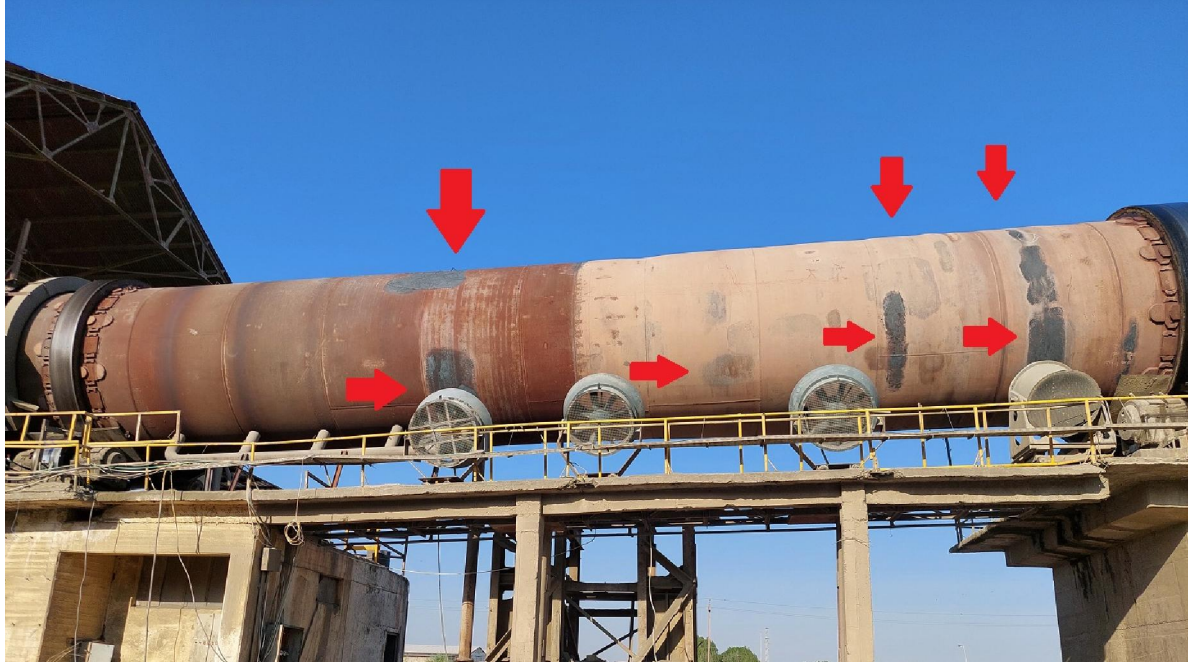
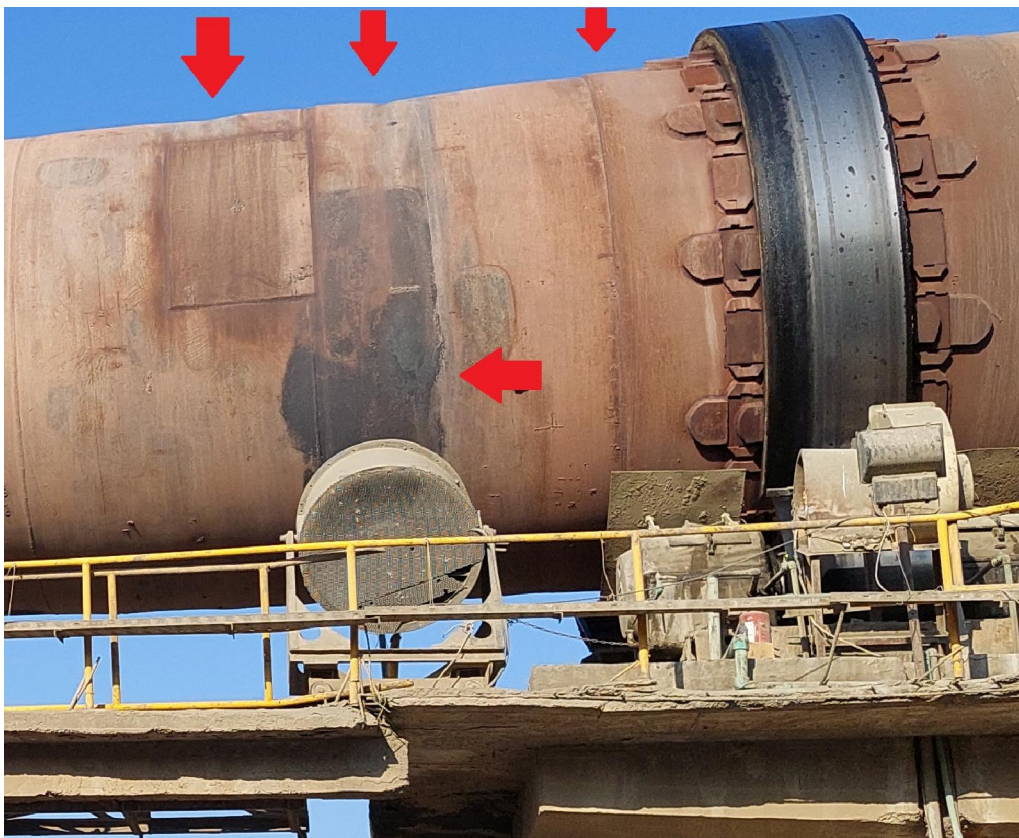
Kiln shell crack increases between the tires , as we checked it , the problem was not in shells connection ( shell welds ) .

Maybe the shell has become thinner than standard and also it has burned in different parts .
