## **HOT KILN ( dryer ) ALIGNMENT ANALYSIS**

### **Sample report of hot kiln alignment in**

Plant ----- Cement Co

Kiln No : 1 ( 4 pier )

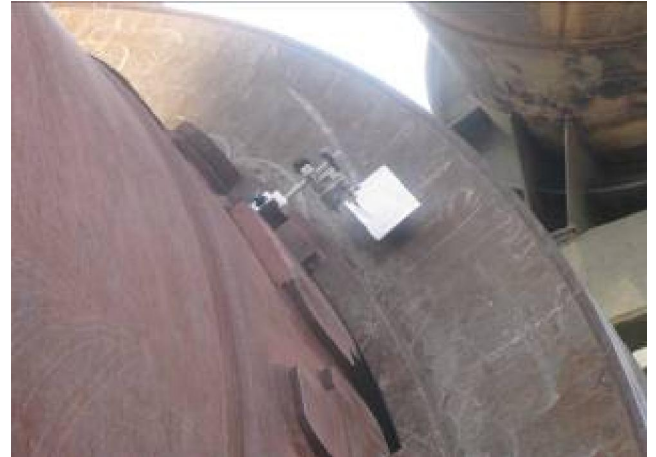
## Creep or tyre ( tire ) migration

| shell & ring | Inlet Pier | mid Pier | outlet Pier |
| creep | 23 mm | 15 mm | 32 mm |

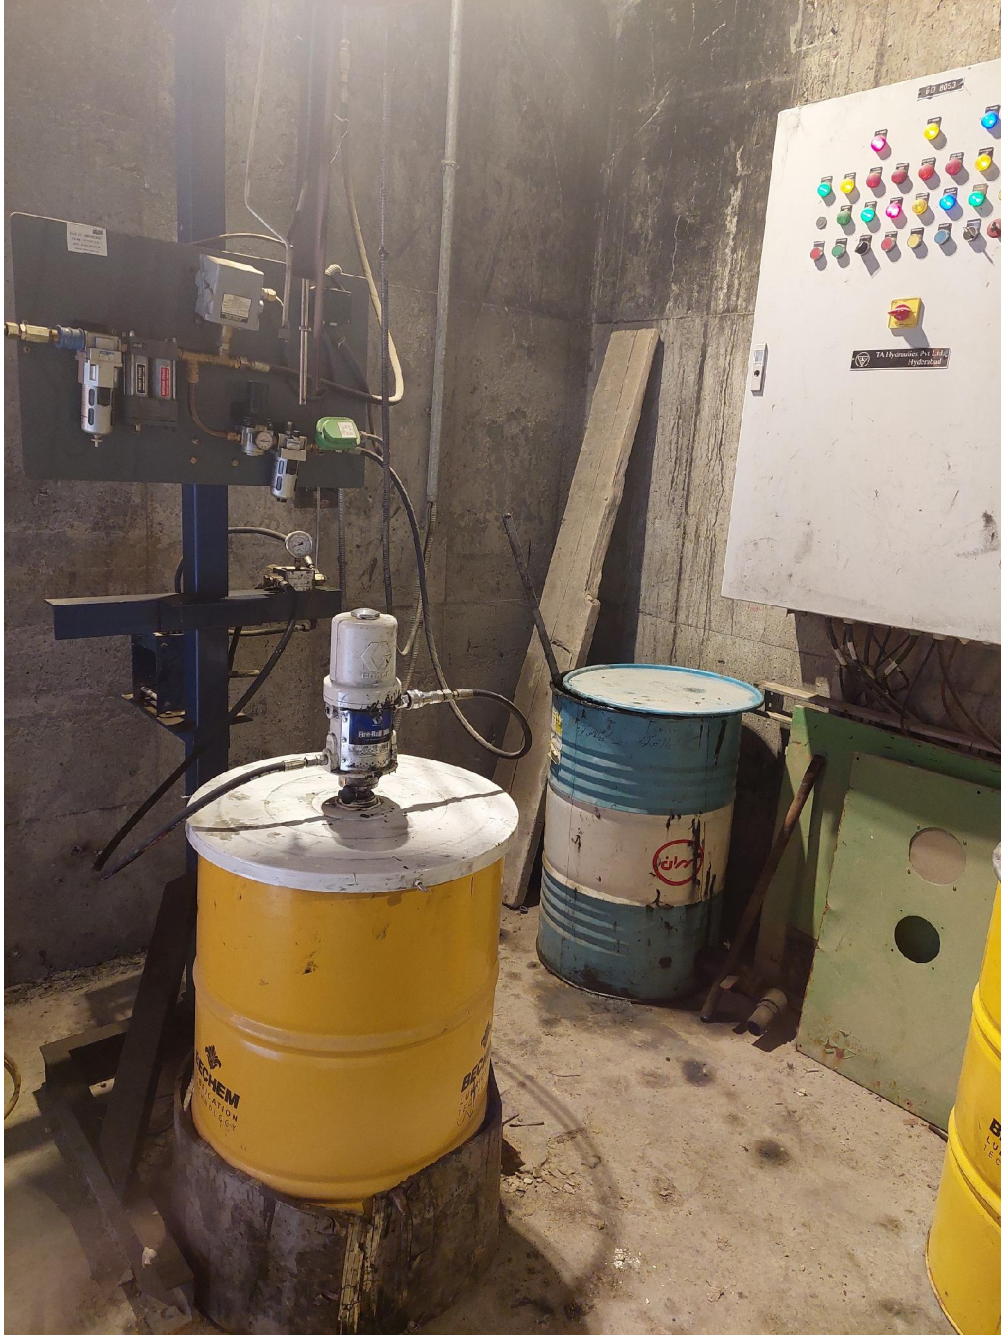
## Grease pump and controller

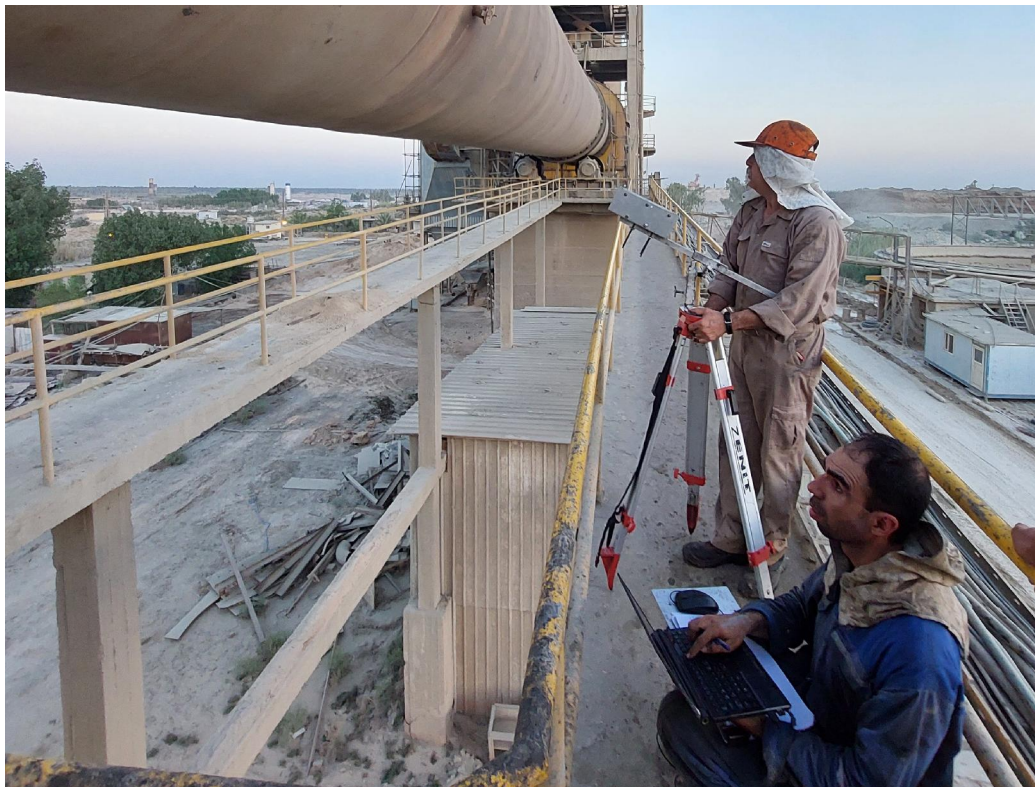
## shell profile
